RAKALI, RIPARIAN AND RIVER HEALTH PROJECT

River Pool Survey Summary

Authors: John & Maryanne Crook
River Conservation Society Incorporated
York, Western Australia

JULY 29, 2025
RIVER CONSERVATION SOCIETY
PO Box 373 York Western Australia 6302

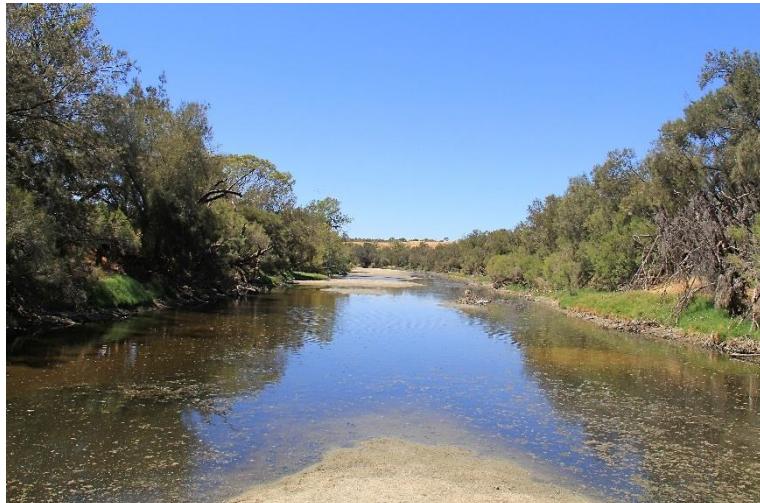
Oakover Pool – Survey Area 1

Oakover Pool consists of an area of water approx. 20m wide by 50m long with a depth varying from 1m to a few millimetres. Extending downstream from the pool there is a long narrow 1km channel, which varies in depth from a few millimetres to 1m. This offered a good opportunity for wading birds feeding on the many small fish and glass shrimps trapped in the drying pool.

1. No suitable rakali habitat or evidence of rakali was detected.
2. A large sand plug covered with upper story vegetation (trees) and negligible understory was present at the upstream end of the pool. Historically this river pool was six metres deep at this location.
3. A narrow strip of riparian vegetation on the left bank was similar to that on the sand plug with a mix of *Eucalyptus rudis*, *Casuarina obesa* and *Melaleuca rhamphophylla* with very little understory except for some introduced wild oats and rye grass. The right bank provided a wider strip of riparian vegetation consisting of *Casuarina obesa* and *Melaleuca rhamphophylla* with an understory of Frankenia, Bluebush and Samphire, about 20m wide, however this narrowed down to just a few metres wide about 100m downstream.

1. Substantial silt movement within the river channel has led to this pool almost totally disappearing.
2. Low water levels, poor water quality, degraded riparian vegetation and a lack of suitable food makes Oakover Pool unsuitable to support a rakali population.

1. No further rakali monitoring of this river pool be carried out at this time.
2. Extensive dredging or sand excavation would be required to restore Oakover Pool to a level where it could sustain permanent populations of large river fauna such as rakali and south-western snake-necked turtles.

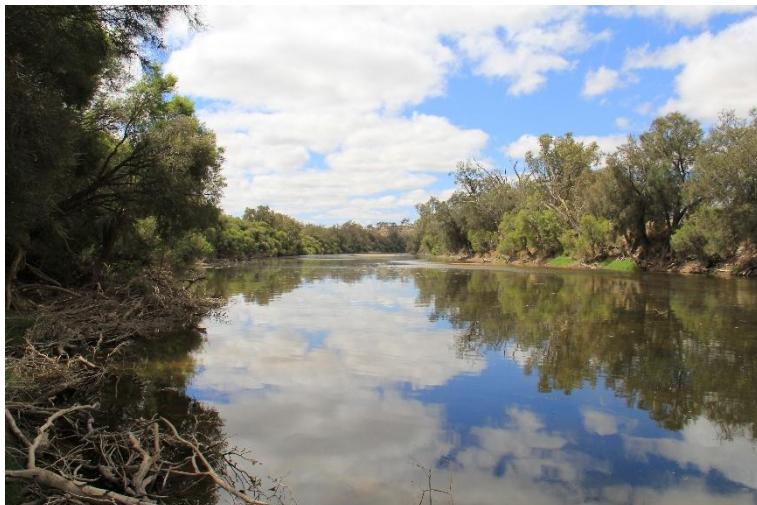
Gwambygine Pool – Survey Area 2

Gwambygine Pool is a large pool approx. 1.2km long and up to 50m wide. The pool varies in depth in summer from an exposed sand plug to 2.5m with normal winter flows increasing the depth by about 1m. It has a hard clay bottom covered with large amounts of silt in some areas. It contains a good variety of submerged logs and snags and has good overhanging vegetation along much of the pool's edges.

1. There is a permanent population of rakali in Gwambygine Pool and the presence of small rakali suggests that they are breeding here.
2. The discovery of dead gilgies, *Cherax quinquecarinatus*, indicates a decline in water quality during the hot summer months.

5. Extended hot dry summer periods may be affecting water quality and food availability.
6. A large silt deposit is accumulating about 100m downstream from the upper end of the pool, which is decreasing the water depth near a known rakali breeding burrow. This could have a negative impact on rakali food sources in this area and make this burrow no longer viable as a breeding site.

7. Native species riparian vegetation along this pool varies greatly in quantity and quality.
8. Sheep entering the riparian zone along the left bank of the pool have destroyed the understory. This has affected the stability of the riverbank, resulting in soil erosion, with soil and manure washing into the pool during heavy rain events. This erosion is exposing the roots of the upper story trees. Damage to these exposed roots by livestock hooves appears to be having a detrimental effect on the health of these trees.

1. Investigate installing predator exclusion fencing along a selected section of right-hand riverbank to protect known breeding and midden areas.
2. Consult with the adjacent landowner and relevant regulatory authorities to try to resolve the issue of sheep entering the river reserve and riparian areas. Have exclusion fencing installed along this section of river.
3. Revegetate selected areas with suitable native species to improve riparian vegetation.
4. Consult with the relevant regulatory authorities to determine if the silt plug can be removed.

5. Work with other groups such as the Balardong Aboriginal Corporation, Wheatbelt Natural Resource Management, and local landholders to try to reduce the amount of silt and chemical run off entering the river upstream of this important rakali habitat.
6. River Conservation Society volunteers continue to monitor Gwambygine Pool for evidence of rakali.

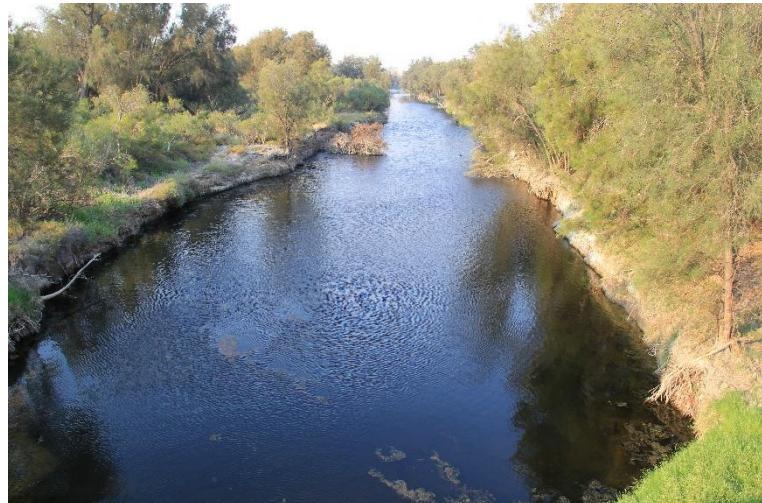
Gwambygine Park Pool – Survey Area 3

Gwambygine Park Pool is a narrow pool approx. 450m long and 15m to 20m wide with mostly steep sides. The pool varies in depth in summer from about 1m to 2.5m. This increases by 1m to 1.5m with normal winter flows. It has a hard clay bottom with a good variety of submerged logs and snags. There is little overhanging vegetation or tree roots in the water, except for a small section at the downstream end.

1. The riparian zone on the left bank is flat and varies from 50m to 100m wide and consist mainly of *Eucalyptus rudis*, *Casuarina obesa* and *Melaleuca rhaphiophylla* and a dense understory of introduced grass. The right bank is much narrower with a flat area of about 5m, then rising to the adjoining farm cropping land about another 10m away. This flat area is also dominated by *Eucalyptus rudis*, *Casuarina obesa* and *Melaleuca rhaphiophylla* and an understory of wild oats and rye grass with some couch grass at the water's edge.
2. A single, large, adult rakali was captured on a camera on two consecutive nights in October 2023. It was foraging for food among tree roots at the downstream end of the pool.
3. No evidence of rakali was found on subsequent surveys.

1. Due to the small size of this pool, the lack of overhanging protective vegetation and no evidence of a good food supply such as gilgies, *Cherax quinquecarinatus*, it is unlikely to support a permanent rakali population.
2. Due to its proximity to Gwambygine Pool this pool may only be visited occasionally by rakali or be used as a transit pool by rakali moving along the river during the breeding season.

1. River Conservation Society volunteers continue to monitor Gwambygine Park Pool for evidence of rakali.

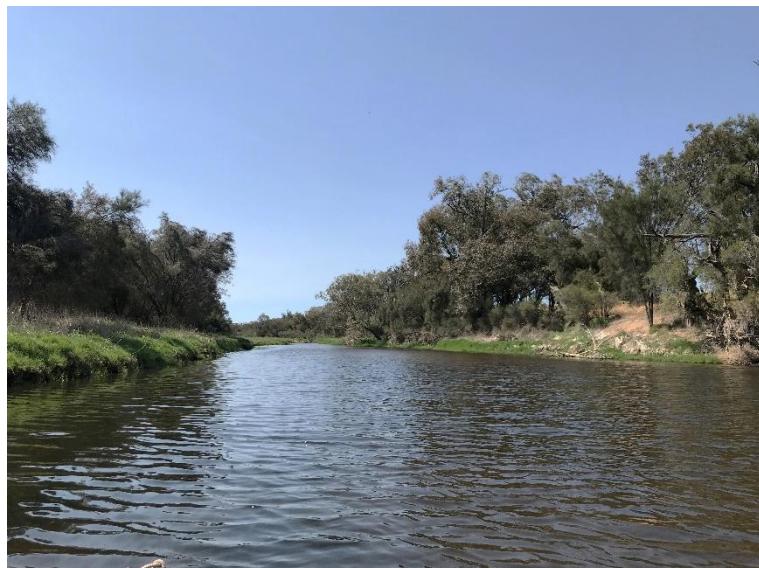
Railway Pool – Survey Area 4

Railway Pool is a small pool approx. 400m long and 20m wide. The pool varies in depth in winter from 1m to 2.5m. This pool almost disappears in summer when it is reduced to about 100m long, 10m wide and less than 1m deep.

1. This pool is heavily silted and almost completely dries up during summer.
2. Riparian vegetation is restricted to a narrow strip of sparsely distributed *Eucalyptus rudis*, *Casuarina obesa* and *Melaleuca rhaphiophylla* with an understory of wild oats, rye grass with some couch grass at the water's edge in places.
3. There was no evidence of rakali found during surveys.
4. The pool edges and riparian zone did not offer suitable rakali habitat.
5. No rakali were photographed at this pool.

1. Substantial silt movement within the river channel has led to this pool almost totally disappearing.
2. Low water levels, poor water quality, degraded riparian vegetation and a lack of suitable food makes Railway Pool unsuitable to support a rakali population.

1. No further rakali monitoring of this river pool be carried out at this time.
2. Extensive dredging or sand excavation would be required to restore Railway Pool to a level where it could sustain permanent populations of large river fauna such as rakali and south-western snake-necked turtles.

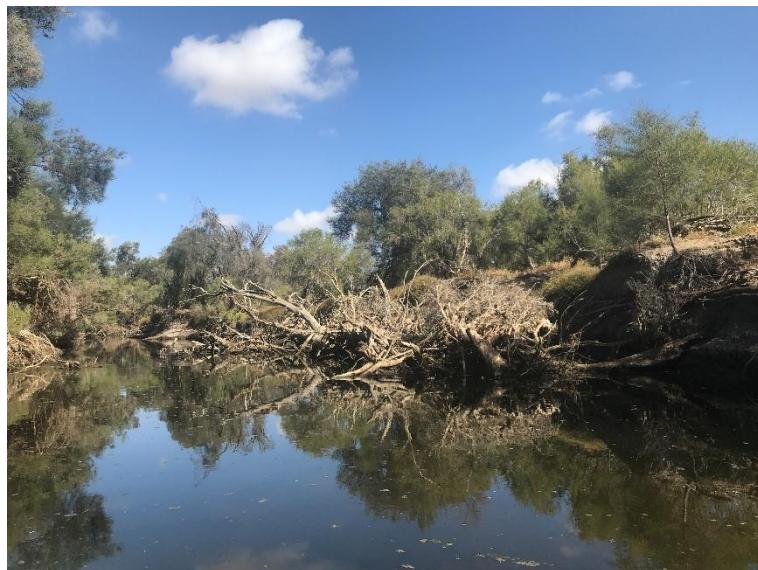
Parkers Reach – Survey Area 5

River Conservation Society volunteers had observed and photographed rakali in this area prior to this three year project. Parkers Reach is approx. 450m long and varies in width from a narrow steep sided channel about 5m across to a low sided open pool about 30m wide. The upper reach is approx. 1.5m deep with a hard bottom littered with snags. The lower reaches are heavily silted and average less than 1m in depth.

2. This pool may only be used as a transit pool by rakali moving along the river during the breeding season.
3. Significant changes in river habitat, damage to riparian vegetation and substantial silting up of the river channel as a result of flooding in 2023 has made this pool unsuitable to support a permanent rakali population.
4. Low water levels and poor water quality during summer months is leading to a lack of suitable rakali food.

1. River Conservation Society volunteers to occasionally survey this pool for rakali activity.

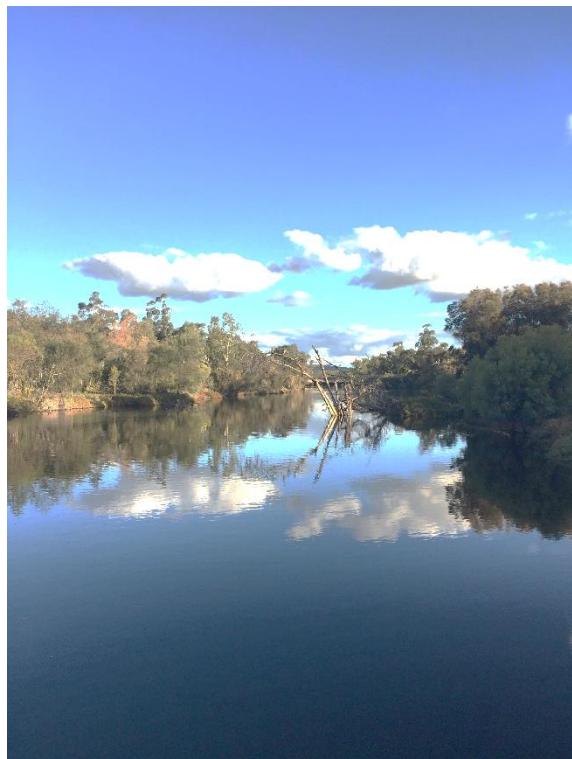
Blands Pool – Survey Area 6

River Conservation Society volunteers had observed and photographed rakali in this area prior to this three year project. Blands Pool is approx. 900m long and varies in width from 35m to about 10m. It also varies in depth from about 2.5m to less than 1m. This pool is heavily silted in places, while other section has a hard rock or clay bottom. These areas are often exposed during the drier summer months.

1. Low water levels and poor water quality during summer may be leading to a lack of suitable rakali food.
2. Domestic geese have been allowed to live on the river in Blands Pool resulting in the loss of riparian vegetation and water fouling. This appears to be having an adverse effect on the limited riparian vegetation and negatively effecting water quality.
3. An off lead dog exercise park next to the river and dogs swimming in Blands Pool may be having an adverse effect on rakali habitat.

1. Approach appropriate authorities to have domestic geese removed from all areas of the river.
2. Consult with local authorities to have the dog park fenced off from the river.
3. Revegetate the riparian zone with suitable native plant species.
4. River Conservation Society volunteers continue to survey this area for rakali activity.

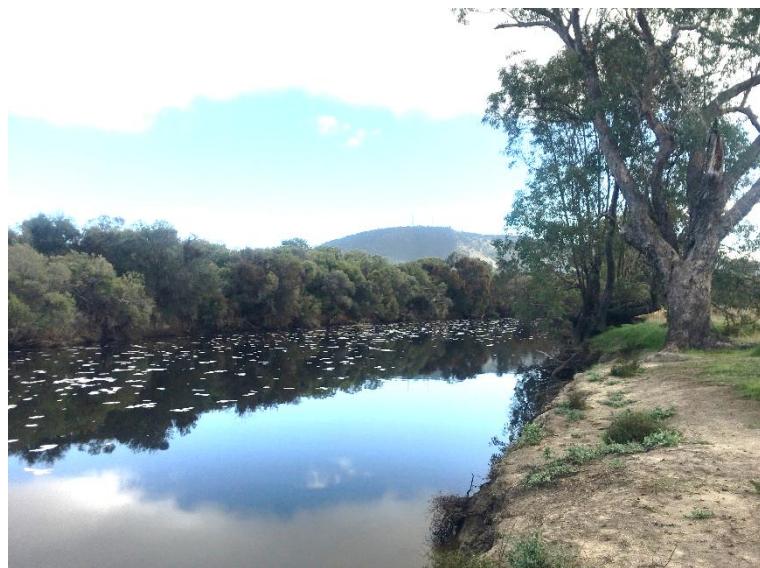
Mile Pool - Survey Area 7

River Conservation Society volunteers had observed and filmed rakali hunting and feeding in this area prior to this three year project. Mile Pool is approx. 500m long and varies in width from 20m to 5m. Depth varies from 2.5m at the upstream end to less than 1m in the silted lower section.

4. Riparian vegetation on the right bank is sparse and consists of a single line of *Eucalyptus rudis*, *Casuarina obesa* and *Melaleuca rhaphiophylla*. However, an intensive revegetation program was undertaken alongside the pool by the River Conservation Society volunteers in collaboration with Wheatbelt Natural Resource Management in 2023.

5. Riparian vegetation on the left bank consists mainly of *Melaleuca rhaphiophylla* with a few *Casuarina obesa* and an understory of invasive wild oats. At the upstream end of this area extensive revegetation was carried out in 2022 by River Conservation Society volunteers. This revegetation consists of *Casuarina obesa* and *Melaleuca rhaphiophylla* and various species of saltbush. This has resulted in dense riparian vegetation in this area. However, it does not extend to the water's edge at this stage.

1. There is a lack of overhanging vegetation and tree roots along the edges of the pool, which diminishes the likelihood of suitable rakali habitat.
2. There is an absence of suitable rakali food.
3. This pool has become a regular place for people to swim their dogs.

1. Consult with local authorities to educate dog owners about the risk to native wildlife caused by allowing dogs to swim in the river pools and the legal requirement to always keep dogs on leads.
2. Further rehabilitate the riparian vegetation.
3. River Conservation Society volunteers continue to occasionally survey this pool for evidence of rakali.

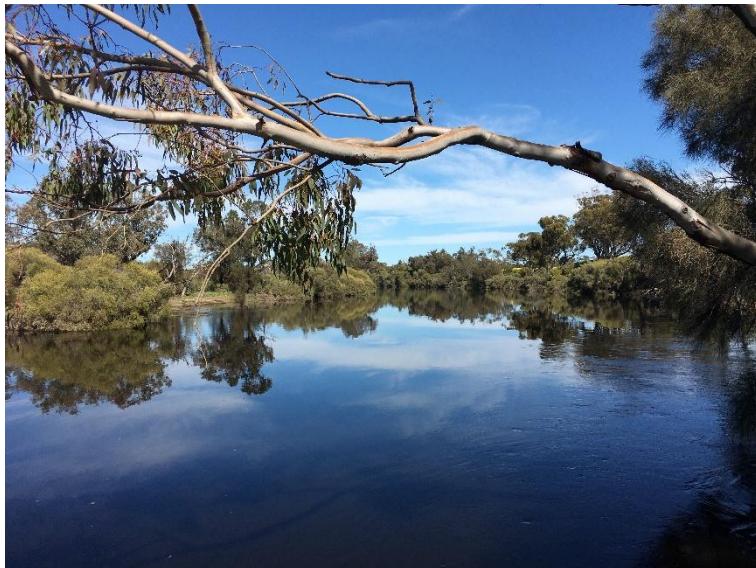
Meares Pool - Survey Area 8

Meares Pool is 400m long, 30m wide and varies in depth from 2m in a small deep section at the upstream end to less than 1m. Most of this pool is heavily silted.

4. Riparian vegetation on the right bank is severely depleted as a result of this area not being fenced and farm cropping occurring within metres of the pool's edge. Vegetation consists of a single line of mixed *Eucalyptus rufa*, *Casuarina obesa* and *Melaleuca rhamphophylla*.

5. Riparian vegetation on the left bank is approx. 10m wide and consists mainly of *Melaleuca rhamphophylla*, *Casuarina obesa* and a few *Eucalyptus rufa*, with an understory of invasive wild oats.

6. At the upstream end of the pool there is a small area approx. 2m deep with several good snags, however the remainder of the pool is heavily silted with an average depth of less than 1m.

2. The average shallow depth of this pool and the overall lack submerged logs and snags does not provide a suitable habitat to support a permanent rakali population.
3. The proximity of farm cultivation to the pools edges maybe contributing to the siltation of the pool.
4. The spring fed pool downstream of the bridge has become an important south-western snake-necked turtle haven and may also be important for rakali transiting through the area in drier times.
5. This pool does not provide suitable habitat to support a permanent rakali population.

1. Extensive dredging of silt would be required to restore Meares Pool to a level where it could sustain permanent populations of rakali.
2. Consult with the adjoining land holder to discuss the possibility of providing a setback and fencing the right bank of the pool to allow for future revegetation.
3. During the recent upgrading of Mackie Crossing, the Shire of York consulted with the River Conservation Society to ensure that no damage was done to the adjacent turtle pool. It is recommended that this consultation continues for any future road or engineering works in this area.
4. No further rakali monitoring of Meares Pool be carried out at this time.

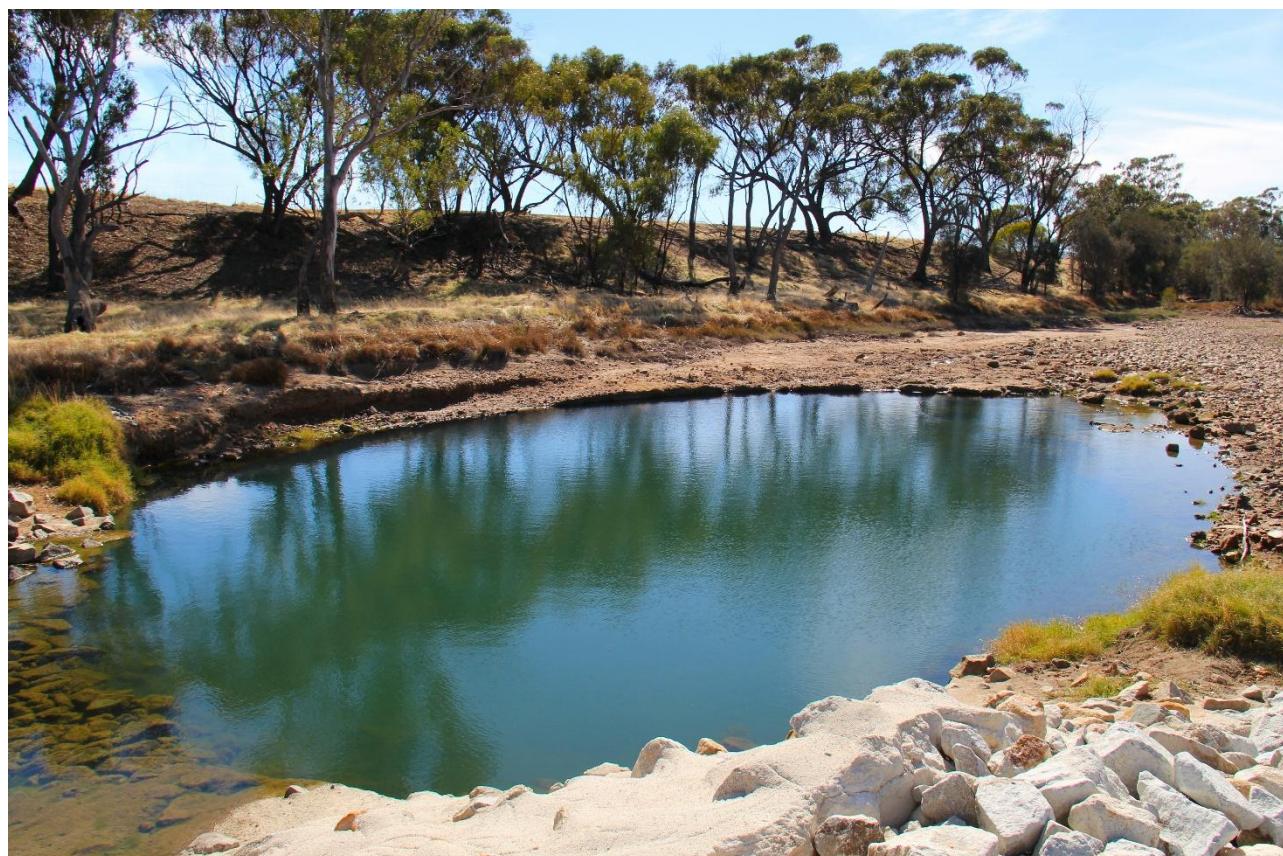
7. At Mackie Siding Crossing, an elevated road and small bridge crosses the river at the downstream end of the pool. Just downstream of this bridge, a circular pool about 15m across and 3m deep with vertical sides has been eroded in the riverbed. This pool sits approx. 1m above the summer level of the main pool and is fed by a fresh spring and has become a summer refuge for a large number of South-western snake-necked turtles, *Chelodina oblonga*. Up to fifteen turtles have been observed here at one time.

Turtle pool downstream of Meares Pool

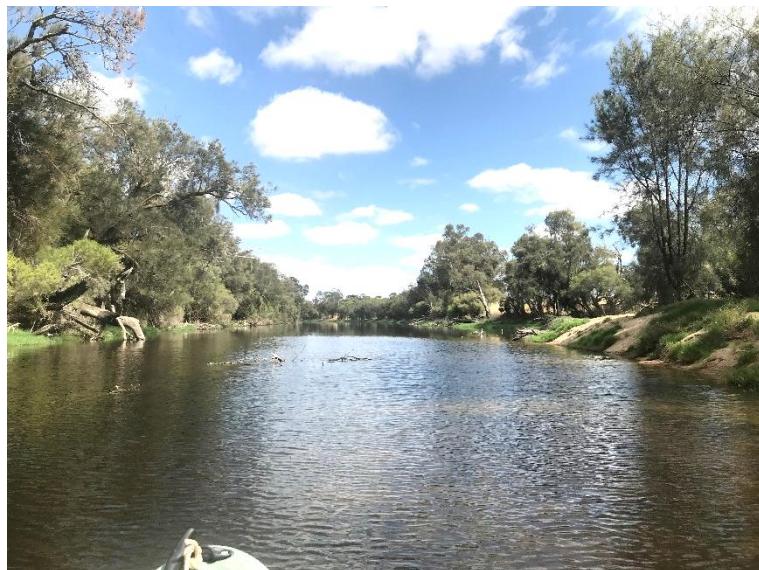
Tipperary Pool - Survey Area 9

Tipperary Pool is approx. 1.3km long and 50m wide in winter, but due to large silt deposits, in the drier months it shrinks back to a pool at the upstream end of about 150m long by 40m wide with a depth of between 2m and a few millimetres.

2. No evidence of suitable rakali food was found at this site.
3. Riparian vegetation on the right bank consists of a narrow strip separation the pool from adjacent farmland. It comprises *Eucalyptus rudis*, *Casuarina obesa* and *Melaleuca rhaphiophylla*, with an understory of Frankenia, Bluebush and Samphire and introduced grass. Riparian vegetation on the left bank is approx. 40m wide and consists mainly of *Melaleuca rhaphiophylla*, *Casuarina obesa*, a few *Eucalyptus rudis* and *Eucalyptus loxophleba*. The understory is mainly invasive wild oats and rye grass, with some couch grass along the edge of the pool.

1. There is an absence of suitable rakali habitat in Tipperary Pool
2. This pool almost disappears during summer due to the large silt deposits that are entering from adjoining farmland through several creeks that flow into the pool.
3. Although the upstream pool has good, submerged logs and snags, it is not large enough to support a permanent rakali population.

1. Extensive dredging of silt would be required to restore Tipperary Pool to a level where it could sustain a permanent rakali population.
2. No further rakali monitoring of Tipperary Pool be carried out at this time.

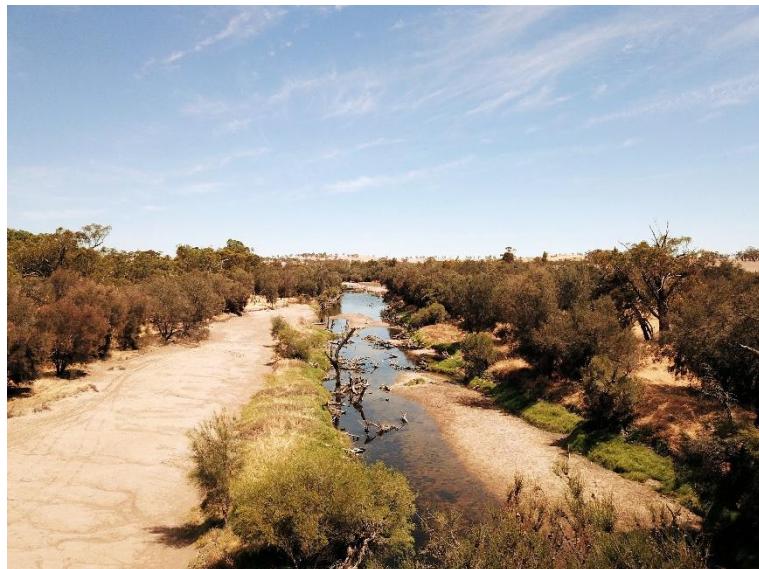
Little Pool - Survey Area 10

Little Pool is almost totally filled with silt and is now no more than a narrow chain of shallow pools approx. 1m deep, stretching over approx. 0.5km that retain some water throughout the summer.

1. Riparian vegetation is restricted to a sparse upper story of *Eucalyptus rudis*, *Casuarina obesa* and *Eucalyptus loxophleba*. The understory almost entirely consists of invasive wild oats with small patches of Frankenia, Samphire and couch grass growing in the riverbed.
2. Some river braiding was observed over the next 0.5km downstream with a few shallow permanent pools.

1. Little Pool does not contain suitable rakali habitat.
2. Little Pool would only be used as a transit pool by rakali moving along the river.

1. No further rakali monitoring of Little Pool will be carried out at this time.

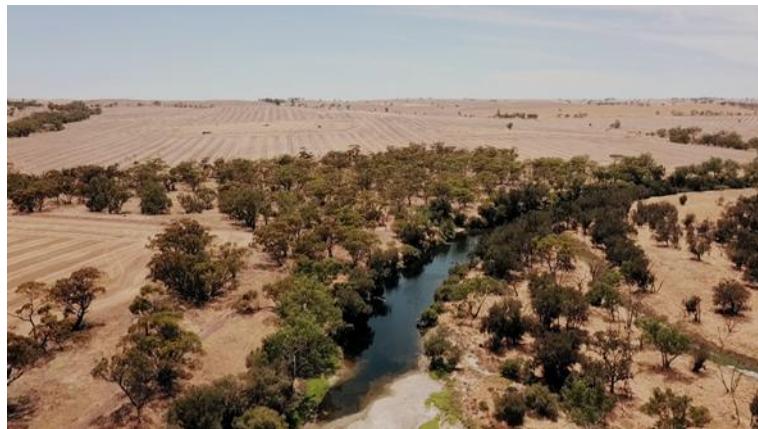
Church Pool - Survey Area 11

Church Pool appears to have once been approx. 1.5km long. However, currently it has large silt deposits along approx. 1km of the upstream end.

The remaining pool is approx. 500m long x 25m wide and appears to have good water depth along the right bank.

1. Difficulty accessing this pool through private property and along the river reserve resulted in limited surveying.
2. Riparian vegetation is sparsely distributed and mostly consists of *Eucalyptus loxophleba*, and *Eucalyptus rudis*. These trees are dispersed over a large area, up to 150m in depth, and separates the pool from farmland on both banks. A narrow strip of *Casuarina obesa* and *Melaleuca rhamphophylla* line the right bank. Although now fenced from farmland, this area appears to have been once heavily grazed and contains very little understory except invasive wild oats.

1. Further attempts be made to secure access to this pool through private property.
2. Re-survey the river reserve to find an alternative track to access this pool by rough terrain vehicle. Current access track is blocked by a change in the river channel.
3. Explore the feasibility of conducting a down river expedition by kayak from Burges Crossing through Church Pool to Wilberforce Crossing.
4. Conduct further drone surveys to continue to monitor pool conditions.

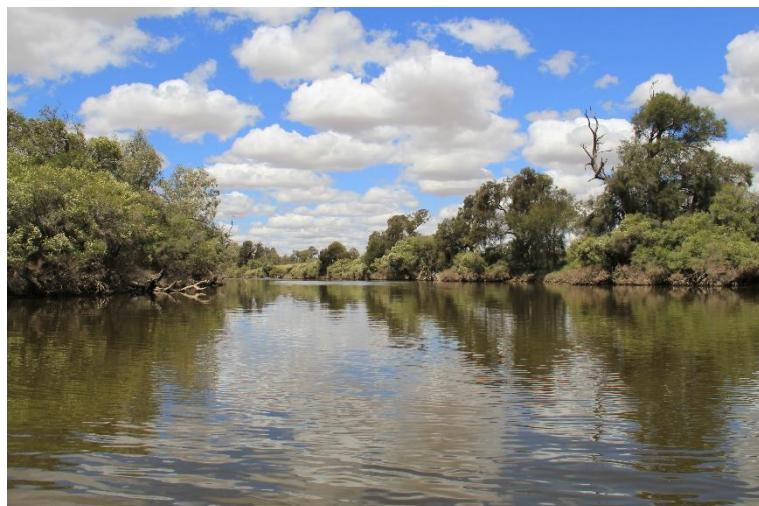
Wilberforce Pool – Survey Area 12

Wilberforce Pool is a large deep river pool. It is 950m long, up to 40m wide 3m deep in some places. It has many submerged logs and snags, and the bottom supports a variety of aquatic plants.

1. During the kayak surveys, evidence of rakali feeding middens and rakali footprints were observed. The remains of a large freshly eaten gilgie were found at a midden; this was later confirmed by the Department of Water and Environmental Regulation (DWER) to be a gilgie displaying a typical rakali chewing pattern.

3. Following flash flooding 2023, many dead gilgies were found washed up on the riverbank at Wilberforce Pool, indicating that there is a healthy gilgie population in the area.
